# Final Report

## Sandringham Sand Management Scoping Study

Prepared for  
Department of Environment, Land, Water &  
Planning

March 2016

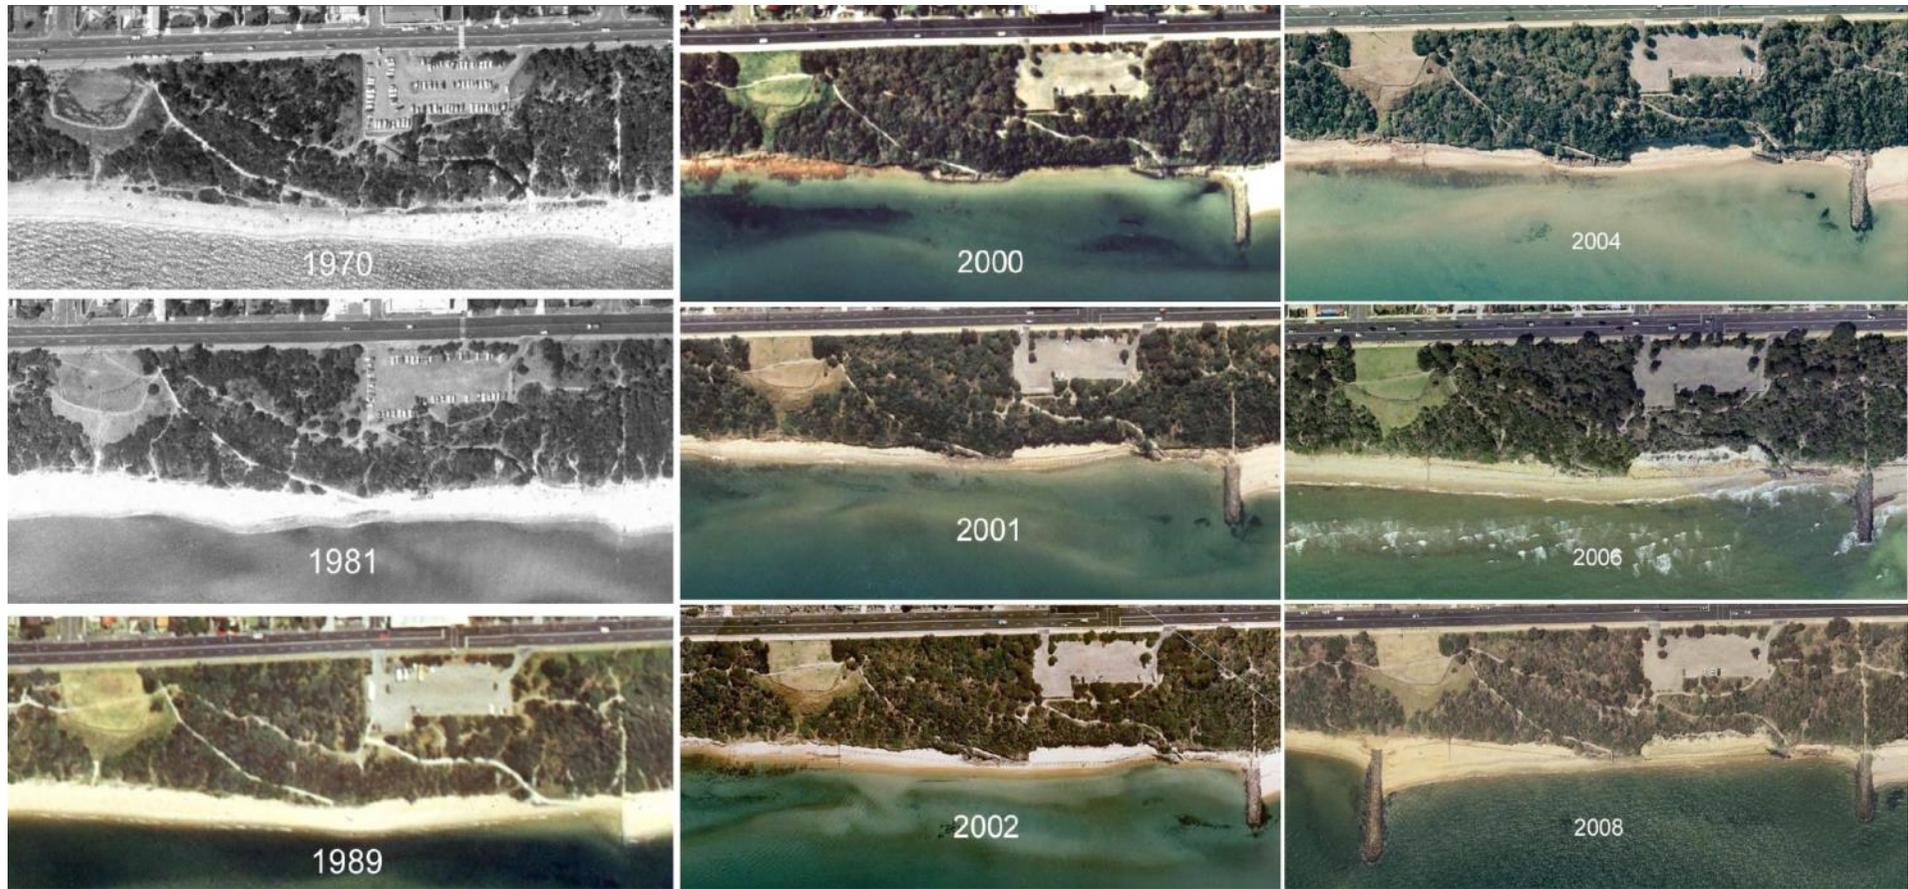
**Figure 3-1 Royal Ave car park area of Sandringham Beach 1970-2008 (Bayside City Council, 2011).**

Noticeable geomorphological changes have occurred at Sandringham Beach in recent times due to natural coastal processes and the construction of two beach groynes. Historic images of the Sandringham Coast show a narrow but relatively stable and seasonally consistent beach prior to the 1990's. A stormwater outfall, in the location of the current Royal Ave groyne, appears to have had a 'groyne effect' on the beach as shown in Figure 3-1 (1989), that is, the building up of sediment on one side and erosion on the other.

Soon after construction in 1990 the beach south of the outfall started to accrete, and the beach north of the outfall started to erode. This was due to the dominant northerly sediment transport in summer. This increased the risk to the cliffs especially during and after the summer months, and lessened the 'buffer' capacity of the beach in these areas during storms. This enabled larger storm waves to penetrate further landward and erode the toe of the cliff. This eventually led to some significant cliff slumping.

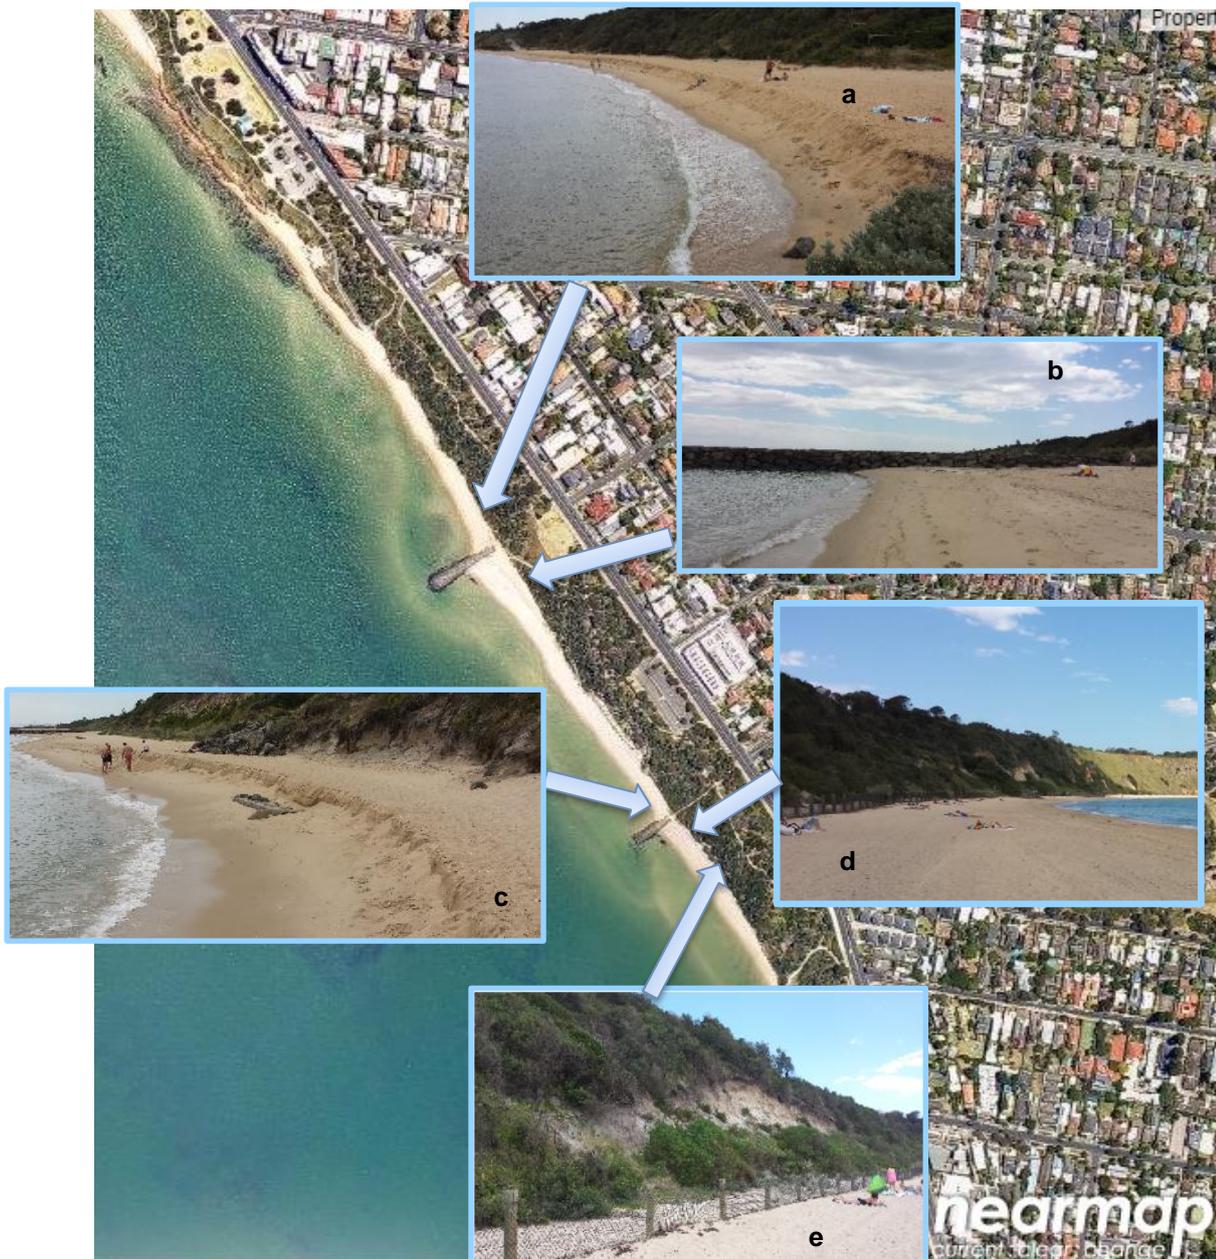
**Figure 4-1 Site visit observations - Dec 2014 (a) scarped narrow beach north of the Southey St groyne (b) wide beach to the south of the Southey St groyne (c) scarped narrow beach north of the Royal Ave groyne (d) wide beach south of the Royal Ave groyne (e) slumped cliff south of the Royal Ave groyne (image: nearmap, 2015).**

On the day of the site visit, it was evident that the summer season sediment transport regime was in effect, with the accretion of sand on the southern side of both groynes forming two wide sections of beach, with some scour to the north of the groynes. Some recent storm damage was evident, with the toe of some cliff sections scarped by wave action (Figure 4-1).

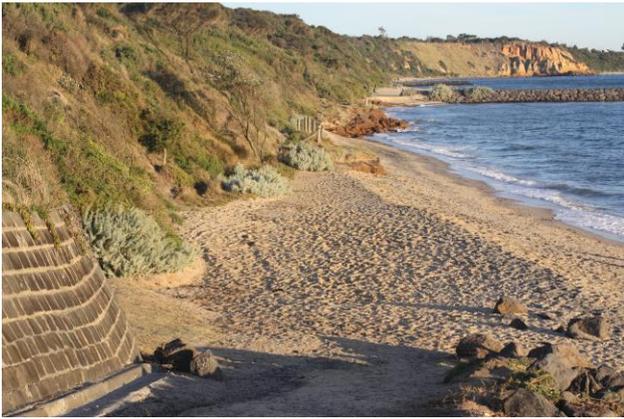
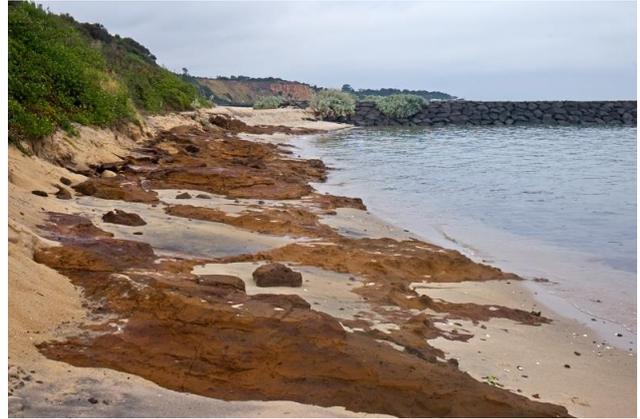
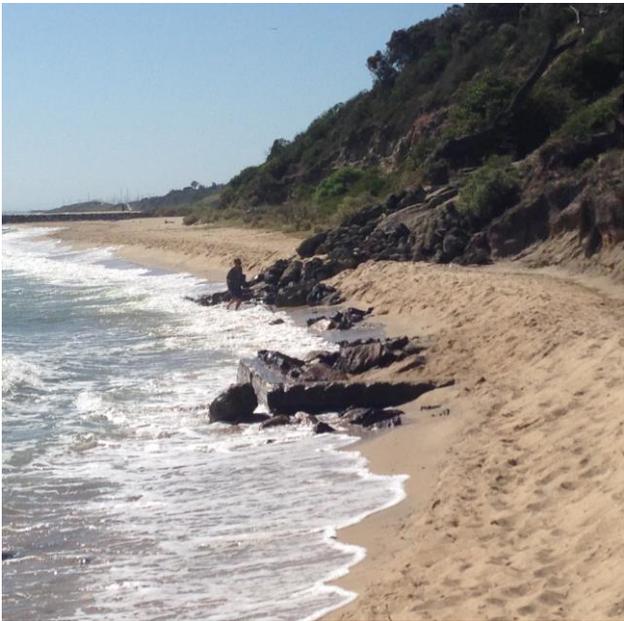
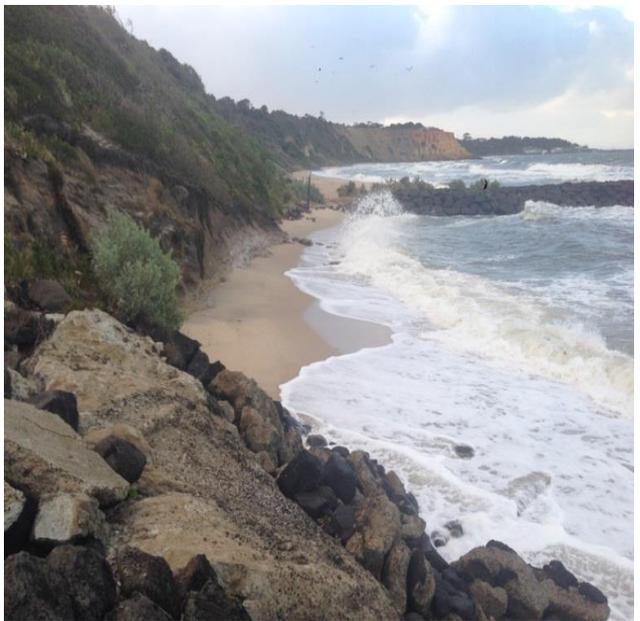
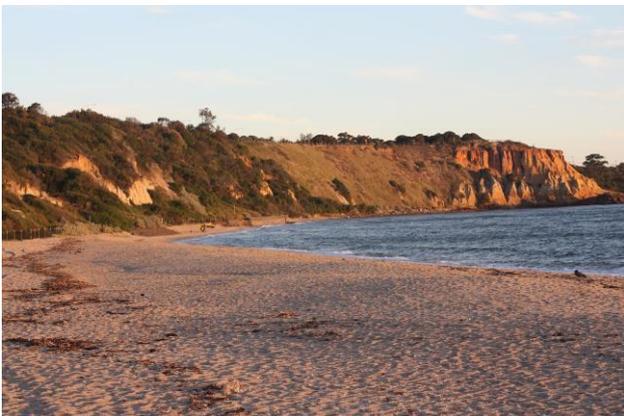
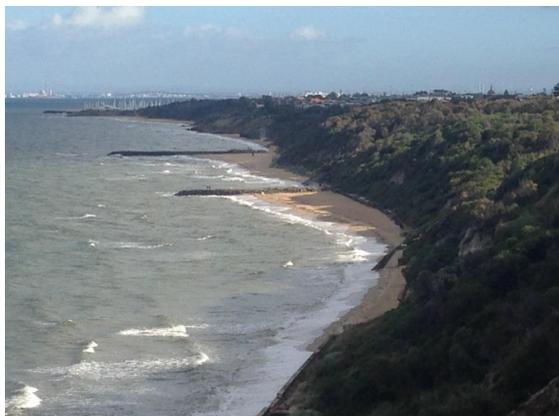
f) Looking north along Sandringham Beach, showing  
lee erosion on the northward side of the groynes  
(March 2015)

**Figure 4-2 Photographs taken in during late summer and early autumn, 2013-16. Source: Dr Vicki Karalis. John Amiet)**

Figure 4-2 below shows the state of Sandringham Beach during late summer and early autumn.

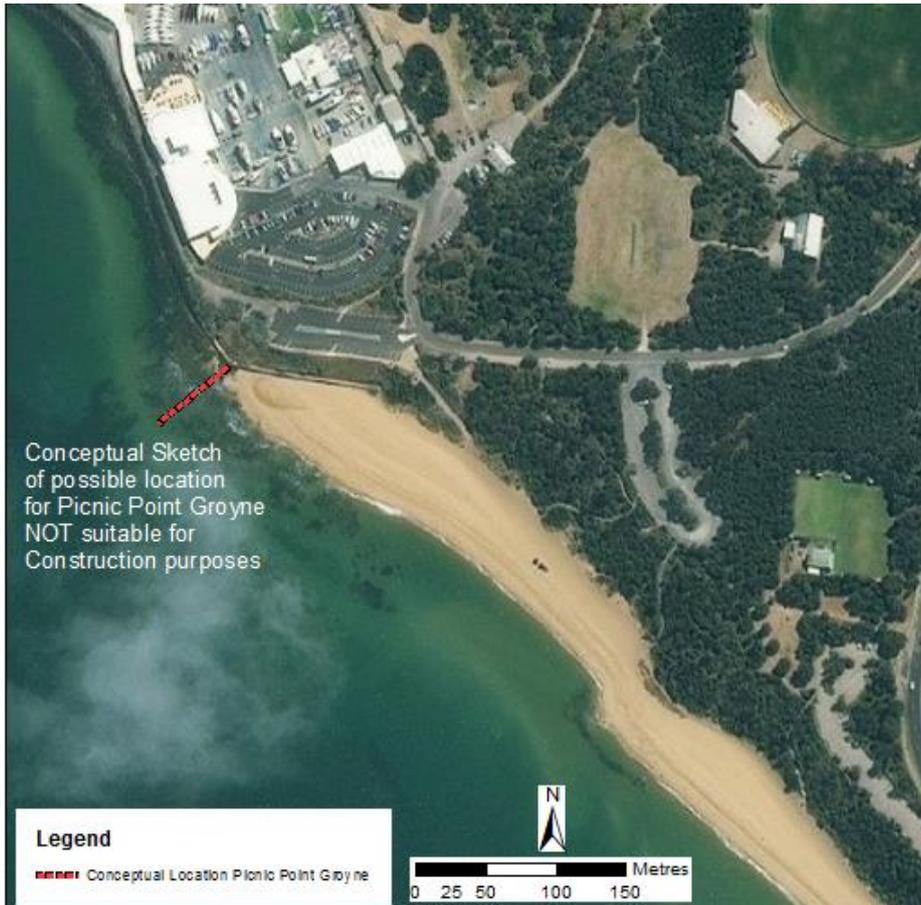
**Figure 5-1 Conceptual Drawing of a groyne at Picnic Point. Note that this drawing is NOT sufficiently accuracy to be used for construction.**

For the purposes of this study assumptions have been made as to the dimensions of a groyne that would be appropriate for the conditions, and to facilitate the desired outcomes of this option. A groyne made of similar rock material with similar dimensions to the Royal Avenue groyne has been assumed to allow for a cost estimate in the assessment process. Recent cost estimates of other similar structures around Port Phillip Bay have been obtained to aid in determining a capital and maintenance cost for the options appraisal process.

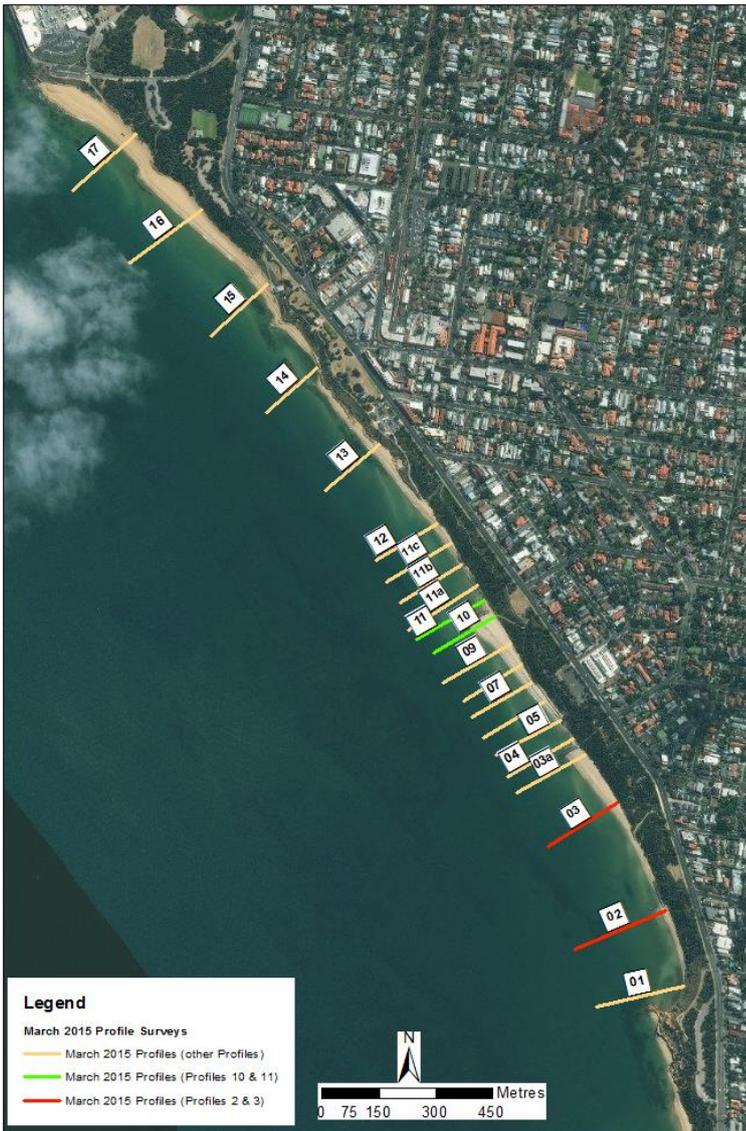
Figure 5-2 Profile locations (Redmapping survey data, March 2015)

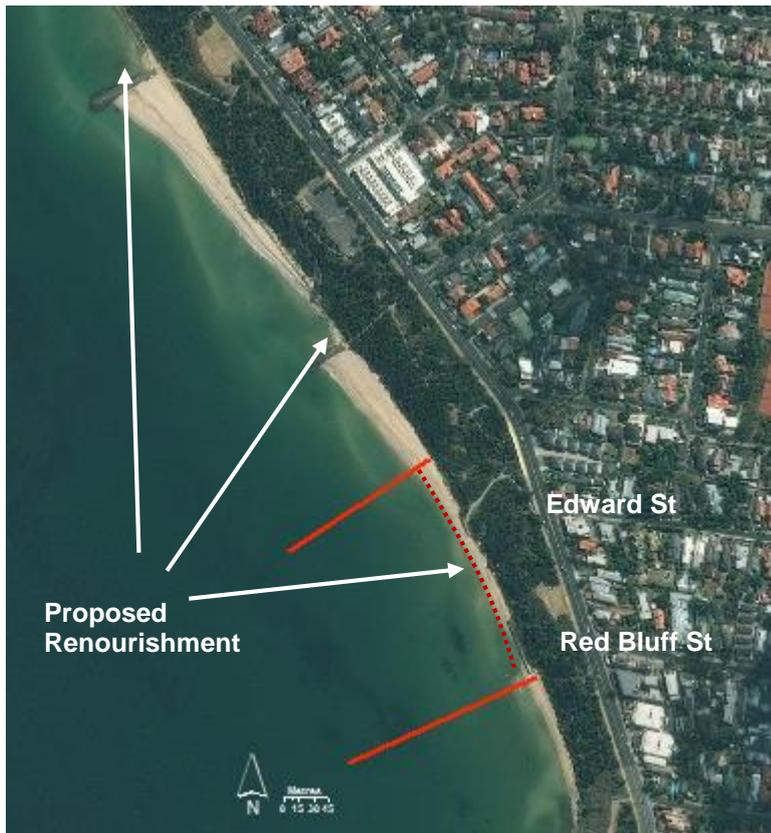
**Figure 5-3 Beach renourishment locations including potential alignment of new beach between Profile 2 and 3 (dotted line).**

This option is to widen and increase the width and elevation of the beach between Red Bluff Street and Edward Street, between the Royal Avenue and Southey St groynes, as well as immediately north of the Southey St groyne. This is primarily to protect the bluffs and structure, but also to increase the amenity. The intention is also to introduce some additional sediment back into the beach cell to be transported within the littoral system. Profile survey information for two profiles (Profiles 2 & 3) in the southern area is available (Figure 5-2); it has been assumed that the renourishment would be carried out between these two profiles (see Figure 5-3). A dotted line shows the potential alignment of the new beach. There would be little difference to the planform shape of the beach at the Profile 3 end of the renourishment; however the beach width would increase at the Profile 2 end. This will widen the sub-aerial beach by approximately 40-50 m after implementation; however this would reduce after the profile equilibrates with the natural coastal processes.

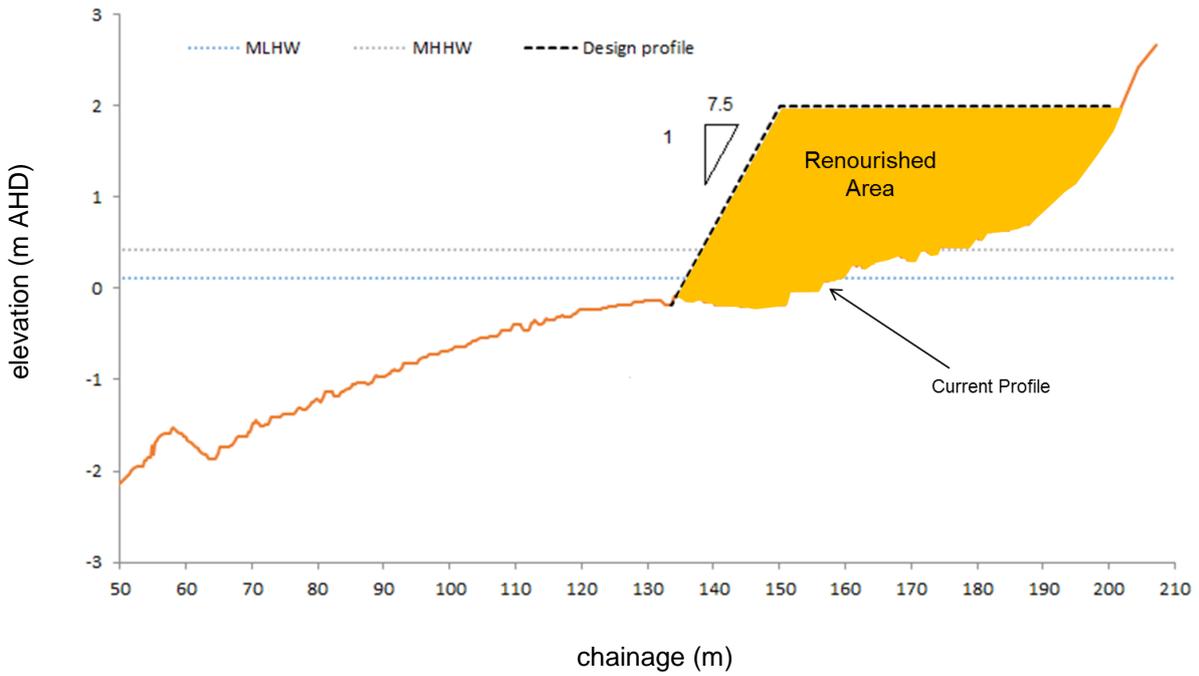
**Figure 5-4 Outline design profile - profile 2 (Red Bluff St)**

Figure 5-4 shows the Profile 2 shape with the renourishment design profile. Figure 5-5 shows the same for Profile 3. The beach is wider here presently than Profile 2, thus the same design would increase the sub-aerial beach width by approximately 10 m. The distance between these two profiles is approximately 250 m. The amount of renourishment required to fill this design would be approximately 12,500 m<sup>3</sup>. This is consistent with Water Technology (2013) who estimated the renourishment volume to be between 10,000 m<sup>3</sup> and 20,000 m<sup>3</sup>. An overfill factor of 1500 m<sup>3</sup> would be incorporated to account for profile losses for a design life of 10 years, resulting in a total estimated volume of 14,000 m<sup>3</sup> for this area. In the detailed design phase, these numbers would be refined. However, the values presented here are considered sufficient to facilitate the technical and economic aspects of the options assessment. An all-in cost of \$30 per cubic metre of dredged/pumped sand, or \$50 per cubic metre of quarry sand has been assumed. These costs will be refined following discussions with DELWP and updated costs from the Brighton renourishment project. The design would also be refined, after consultation with the community as to the amenity requirements at this beach location. There is a variance in grain size, larger grain size will stay in position longer and cost for different grain size/type of sand will need to be considered

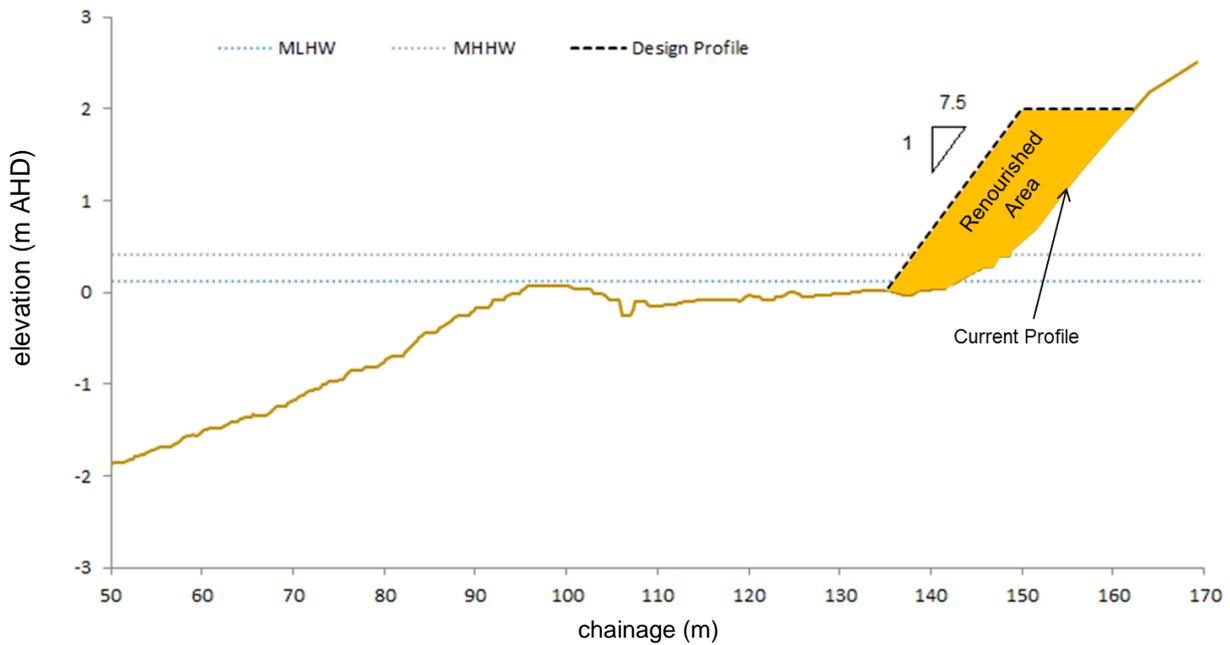
**Figure 5-5 Outline design profile - profile 3 (Edward St)**

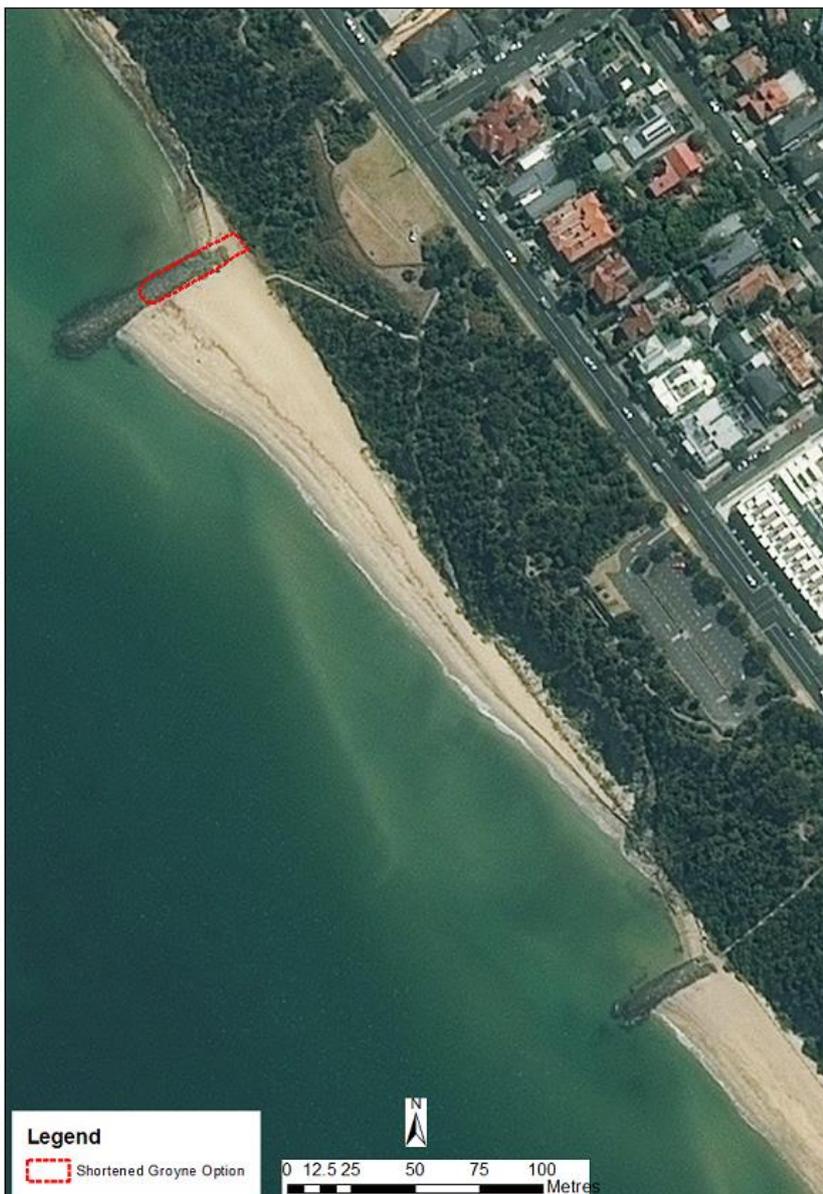
**Figure 5-6** Optional shortening of the Southey Street groyne. The length of original groyne is approximately 100 m, length of the shortened groyne option approximately 50 m.

The intention of this option is to encourage more sedimentation north and south of the groyne, by lowering and shortening the groyne to allow overtopping and more sand to bypass naturally (Figure 5-6).

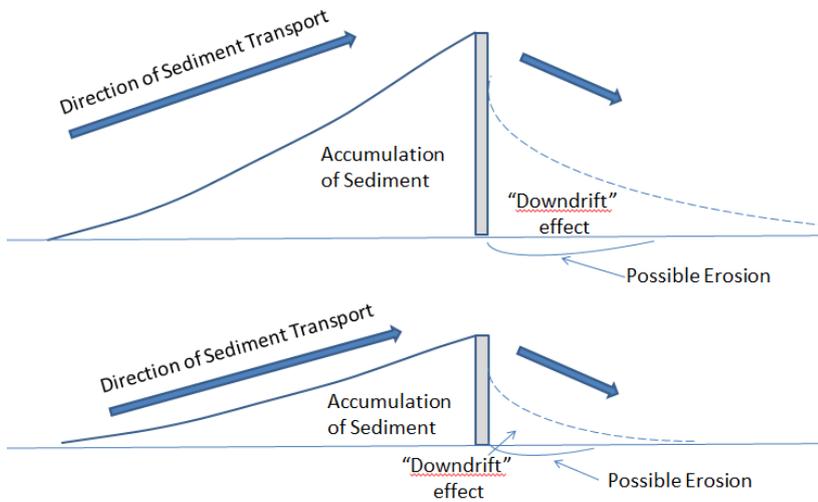
**Figure 5-7 Conceptual sketch showing effects of groyne shortening. Note that the potential for erosion on the downdrift site of the groyne still exists if it was shortened. Only the complete removal of the groyne would remove this effect. However, this is likely to be the detriment of the coast updrift of the groyne.**

These potential volume changes are not likely to be sufficient to improve the seasonal erosion problems south or north of the Southey Street groyne as localised scouring will always be present as a result of sediment transport (Figure 5-7).

Nevertheless, a shortened groyne may cause less erosion on the leeward side, as shown in the conceptual sketch below (Figure 5-7). However, this requires detailed analysis of the groyne shortening effects, and consideration of local factors, including seasonal reversal of longshore transport.
